MERRIMACK RIVER BASIN
NELSON, NEW HAMPSHIRE

NUBANUSIT LAKE DAM

NH 00339

PHASE I INSPECTION REPORT
NATIONAL DAM INSPECTION PROGRAM

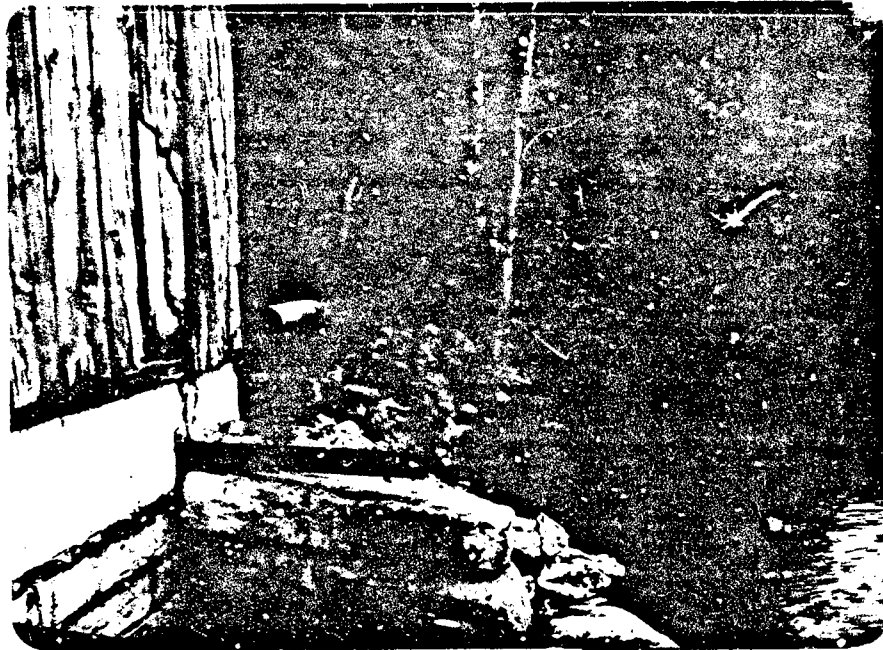
Overview of right side of dam from gatehouse

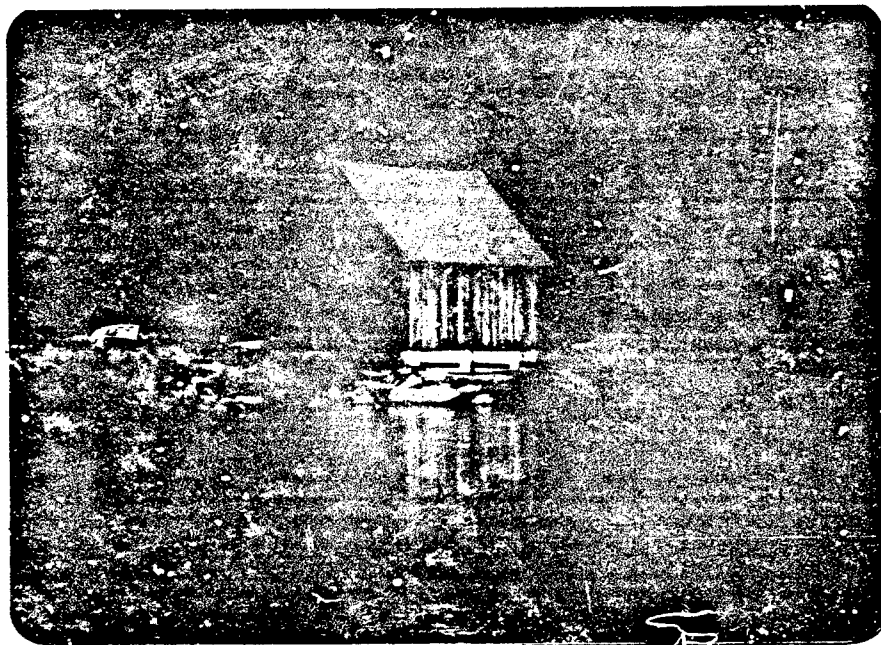
Overview of gatehouse near center of dam from upstream

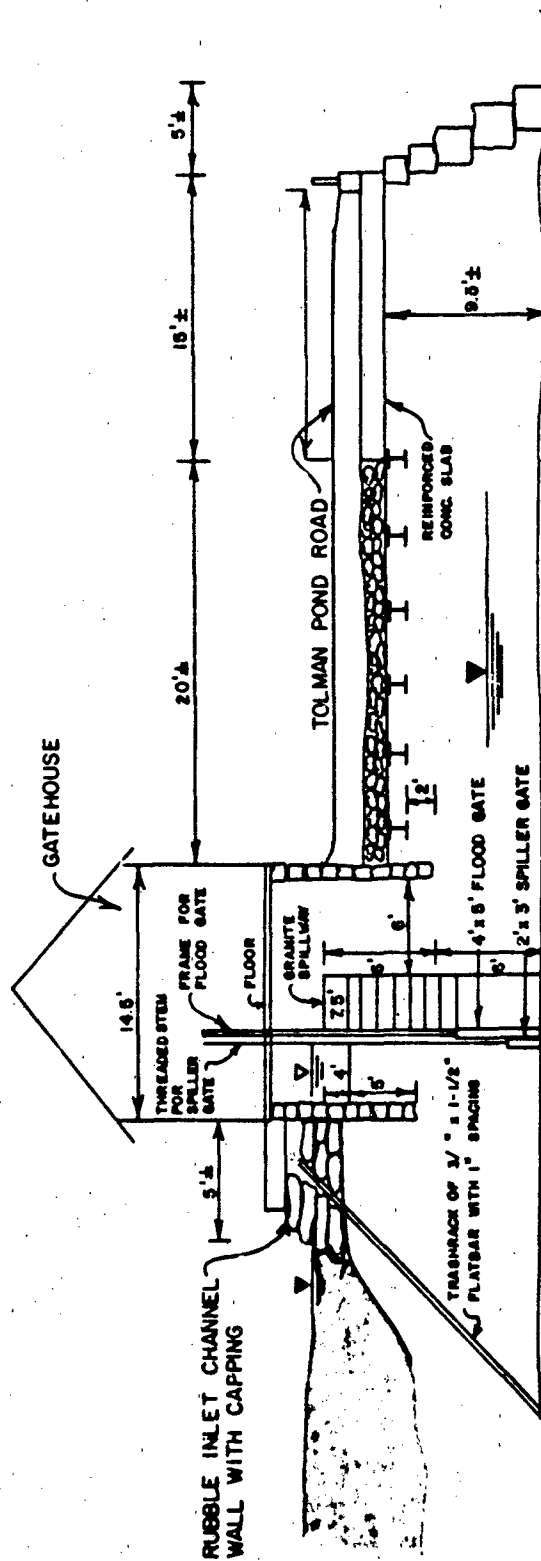
SECTION C-C'
SCALE: 1" = 10'

NOTE: WATER LEVELS MEASURED
18 JULY 78. WATER FLOWING 4" OVER
SPILLWAY DURING INSPECTION.

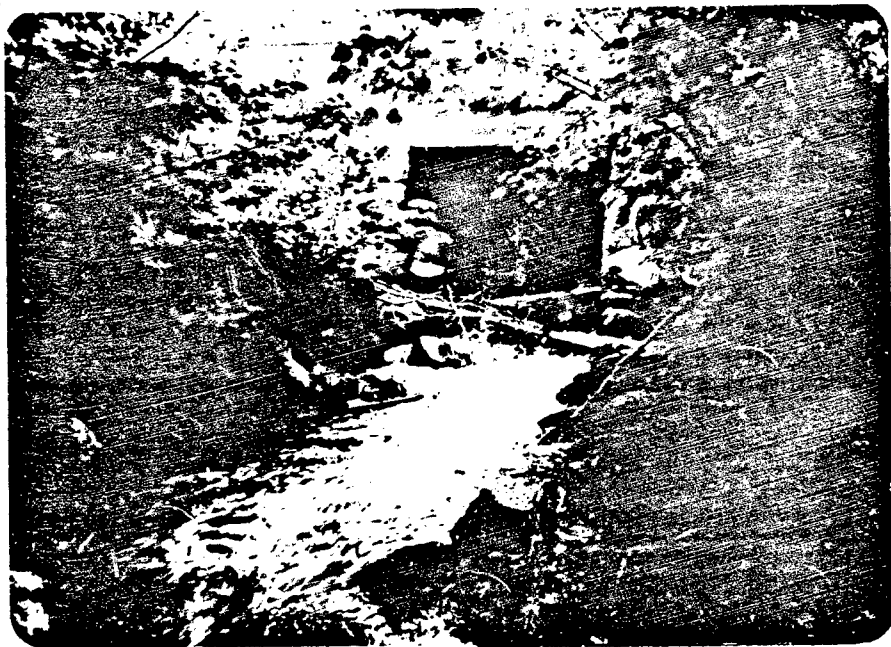
1. View of outlet area and downstream channel

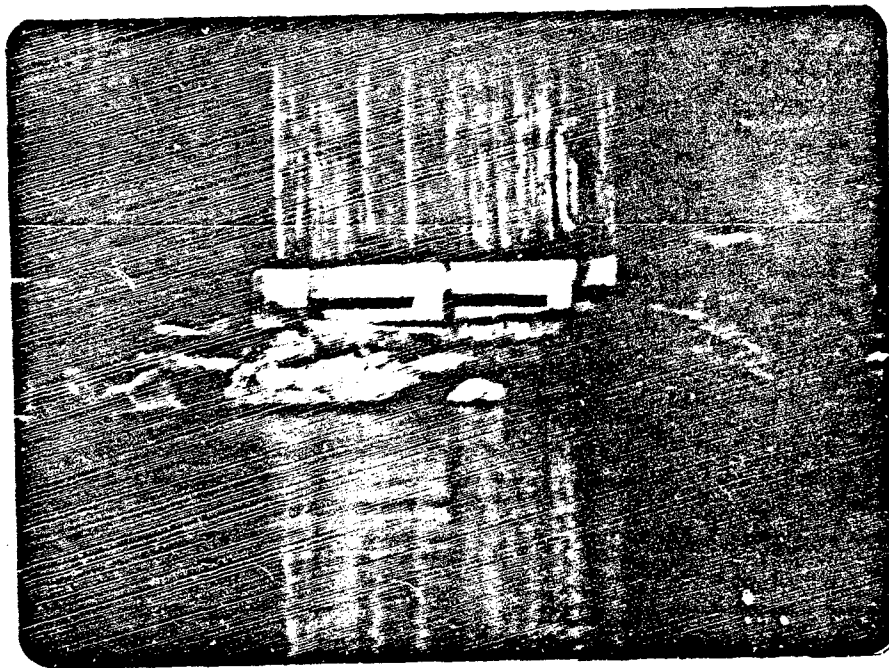
The trash rack upstream of the gate house waterway opening, although slightly rusted, is in good condition. The concrete wingwalls on either side of the trash rack are badly deteriorated with open joints and dislodged stones.

2. Detail of gatehouse inlet from upstream

- (3) Repair the deterioration to the upstream wing-walls by resetting all stones and mortaring all joints.
- (4) Remove all trees and brush from the embankments. Consultations should first be held with forestry experts on the implications to the dam of removing mature trees over 3 inches in diameter.
